PHOTOGRAPHIC INTERPRETATION REPORT

CHIN-HSIEN AMMUNITION DEPOT ERH-SHIH-LI-PU, CHINA

NPIC/R-1161/64

COORDS: 39-12N 121-44E NPIC TARGET NO: 0381-10-E

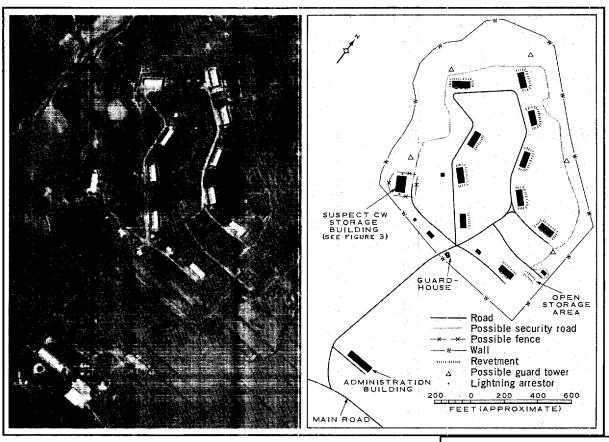
FIGURE 2. CHIN-HSIEN AMMUNITION DEPOT ERH-SHIH-LI-PU, CHINA

Storage Buildings. There are ten revetted or partially revetted storage buildings measuring approximately 95 by 35 feet (Figure 2). Two of the buildings have three loading platforms, one has two platforms, and the remaining seven have no visible platforms. No firewalls,

blastwalls, or ventilating devices of any kind are visible on any of the buildings.

There is one additional storage building that has nine small pipe vents on the roof (Figures 2 and 3). The building measures 90 by 50 ft and has a floorspace of approximately 4,500 sq ft. There is a lightning arrestor erected on the ground close to each end of the building. The building may be separately secured by a fence

within the walled area.

There are five small buildings scattered along the southern side of the compound. The purpose of these buildings is not known. An open storage

area containing a large number of unidentified objects is situated near the SE corner of the secured area.

Security. The site is enclosed by a wall, within which there are five possible guard towers connected by a separate possible security road. There is a guardhouse at the entrance to the secured area.
